Inspection Order No. : IN-TJ-5602-14161-02rev1

INSPECTION REPORT

- Description and Quantity of Commodity: (As per packing list no.: SXS14EL-014 MAY.19,2014) Ductile Iron Pipe DN900 C30 / 1241pcs

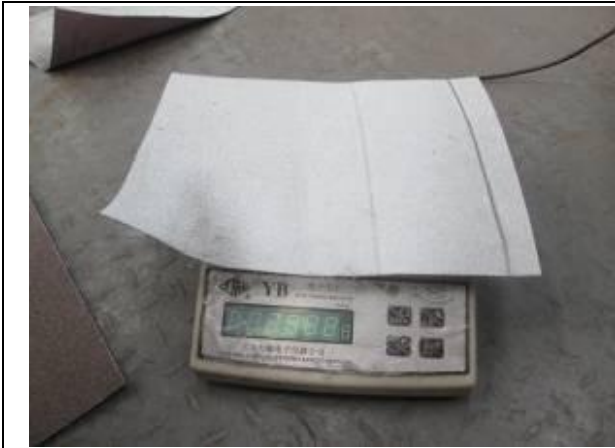
Witness zinc mass test

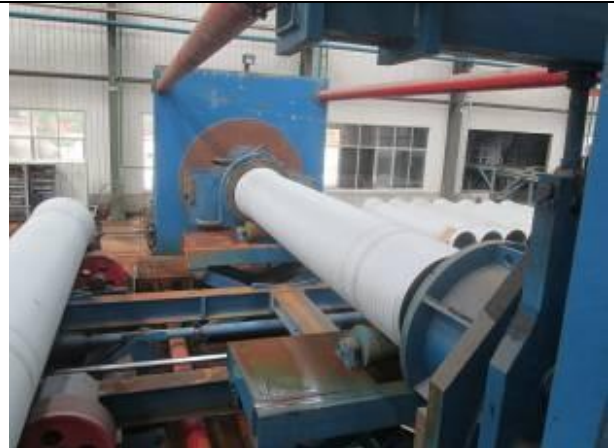
Result: During the test, no visible leakage, sweating or any other sign of failure was found, the result of witness hydrostatic test was acceptable.

Witness hydraulic test

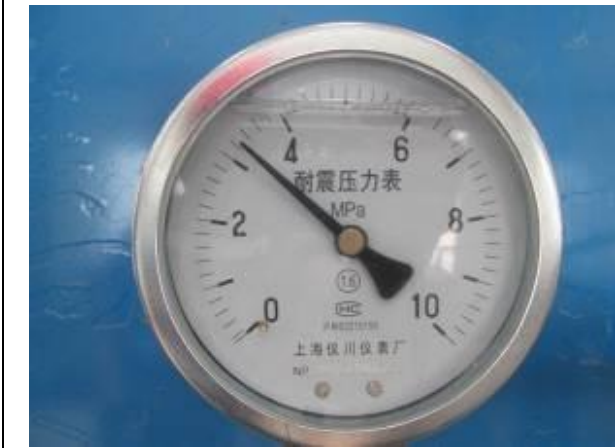
Test pressure

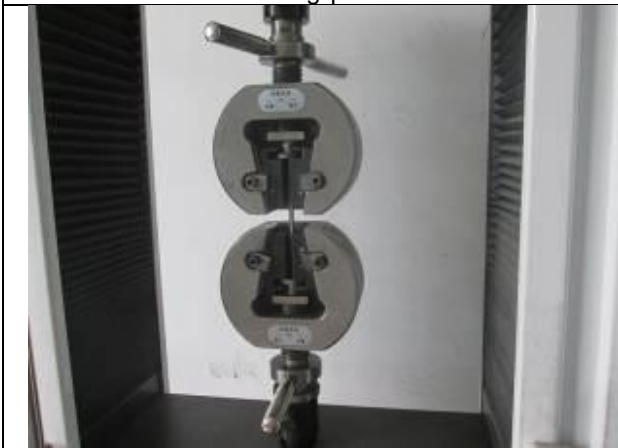
Witness tensile test

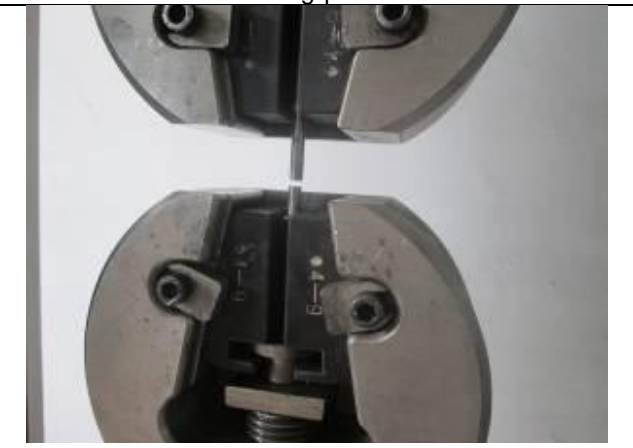
Witness tensile test

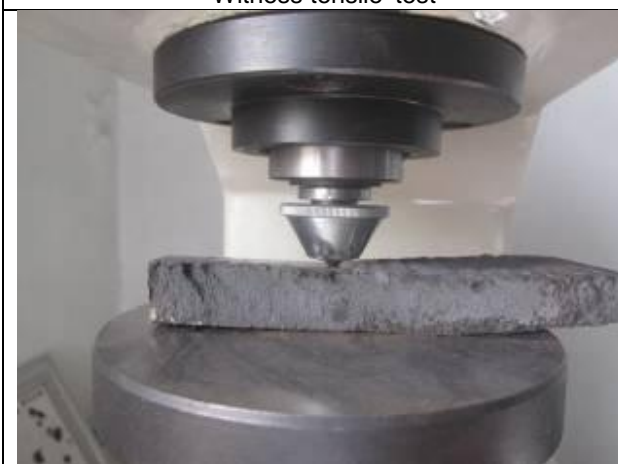
Witness hardness test

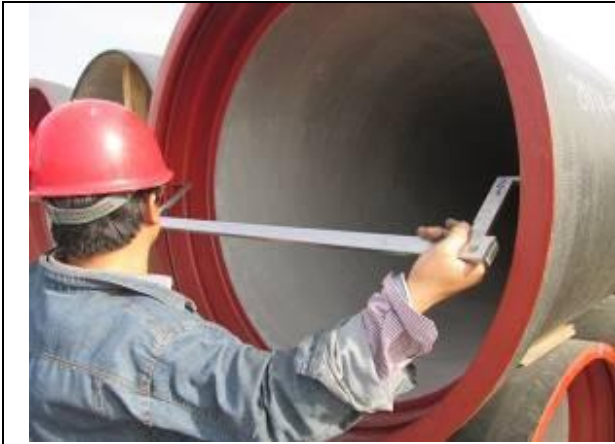
Result: The result of dimension check was acceptable.

Dimension check

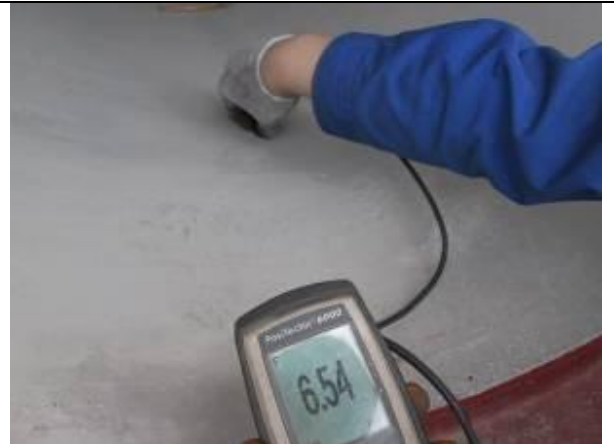
Thickness of Lining cement

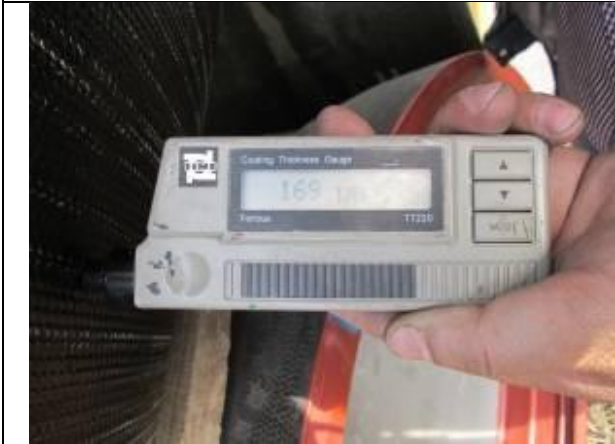
Thickness of bitumen coating

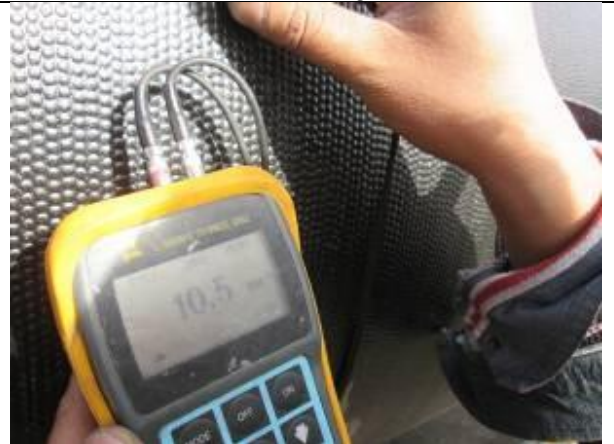
Wall thickness check

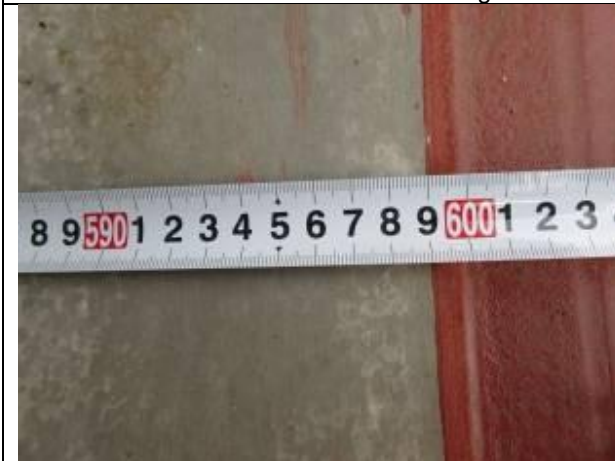
Length check

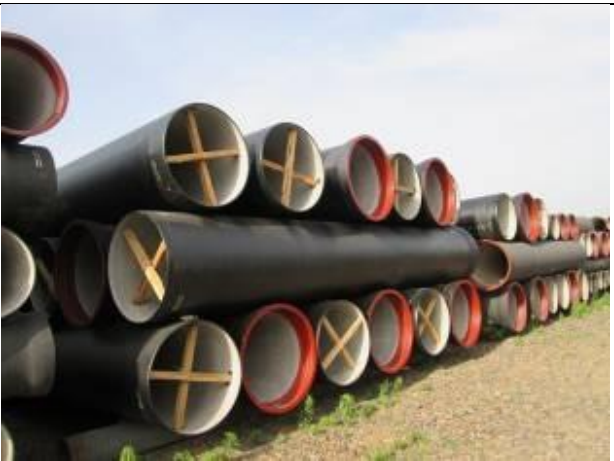
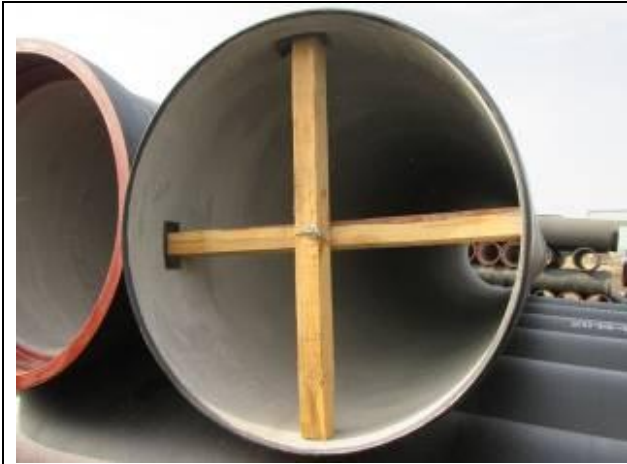
The pipes were in bulk, the crossed wooden block was found in pipe's spigot end.

Packing check

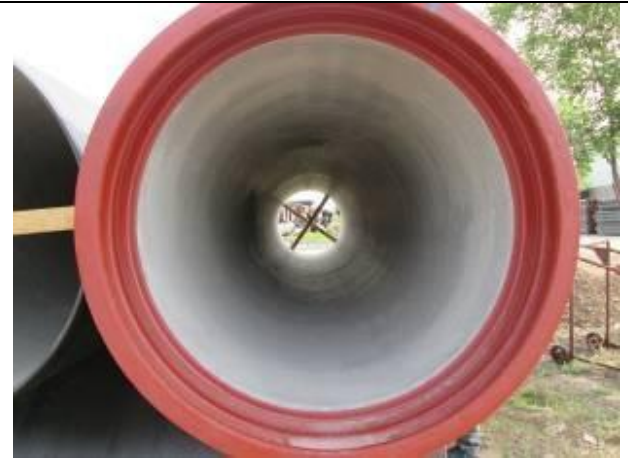
During the inspection, 60pcs pipes were selected randomly for visual quality inspection. The pipes were found painted with black coating on external surface and lined with gray lining on internal surface, the socket of the pipe was painted with red coating on internal surface. Surface condition of coating and lining was generally smooth. No obvious defects on the visual quality of the pipes were found.

Visual quality check

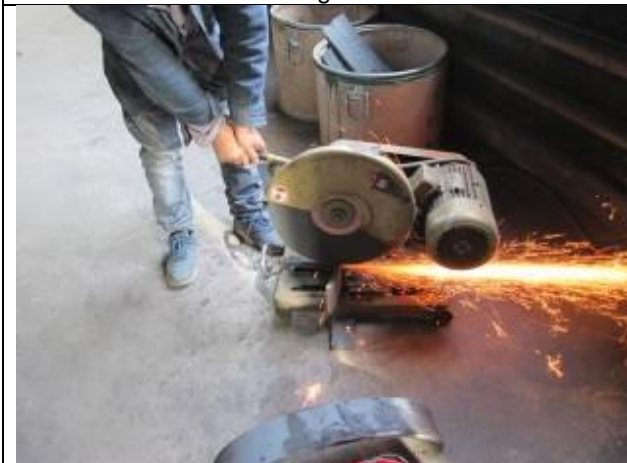
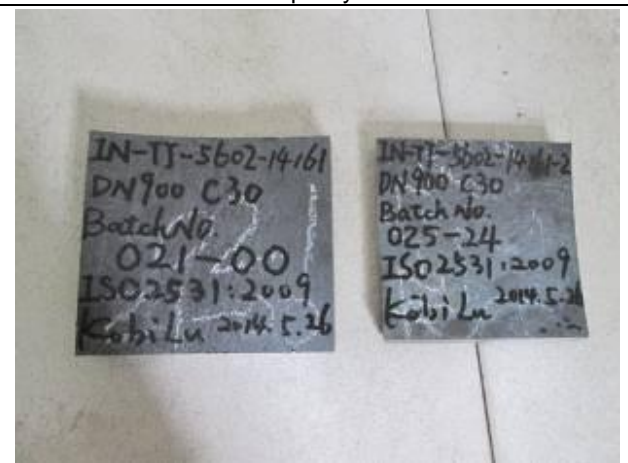
Sampling

2 Samples
