Inspection Order No. : IN-QD-PSI-09039
Boss No. : 11725090
Page No. : 1 of 6
Date of Issue: Apr. 07, 2009

INSPECTION REPORT
(non-negotiable)

- **Description and Quantity of Commodity:** Ductile Iron Pipe DN500 (with rubber gasket): 667 pcs

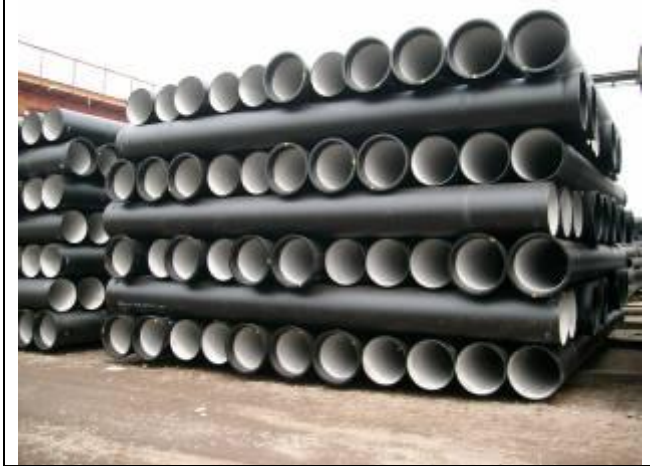
- Found all Ductile Iron pipes were in bulk.

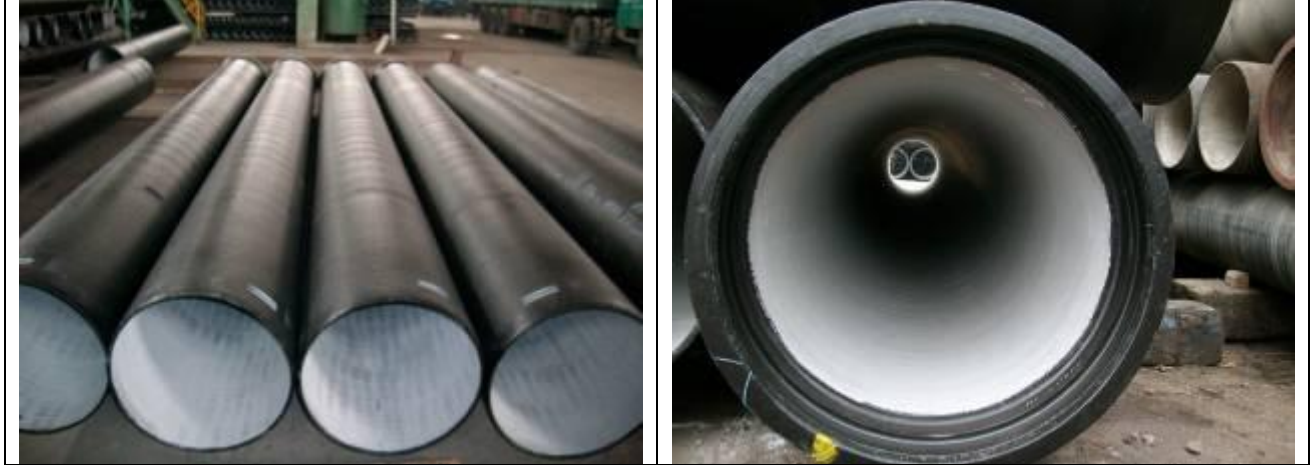
According to the ANSI/ASQ Z1.4-2003 single planning for normal inspection Level II, total 80pcs pipes were randomly selected for visual quality check, found the outside of pipes and inside of socket were coated with black epoxy and inside of the pipes were cement mortar lined, and the pipes we inspected were in normal condition.

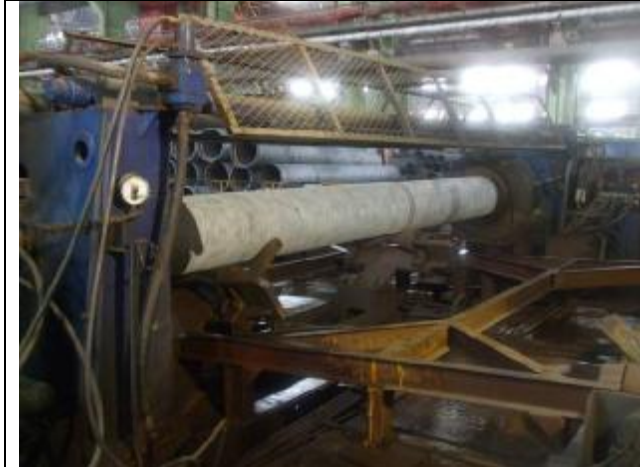
Hydro test

Result: No visual leakage was found. Passed.

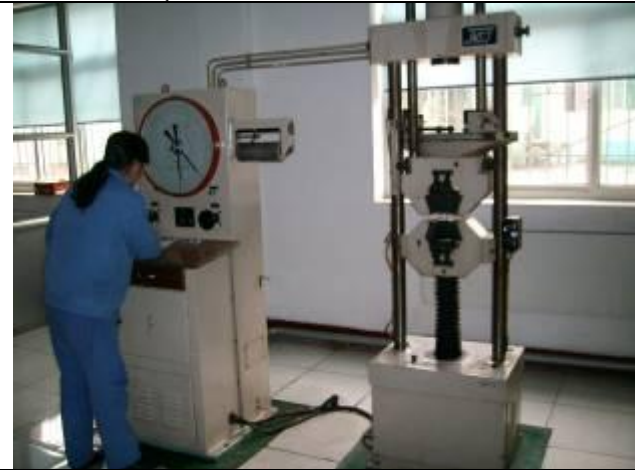
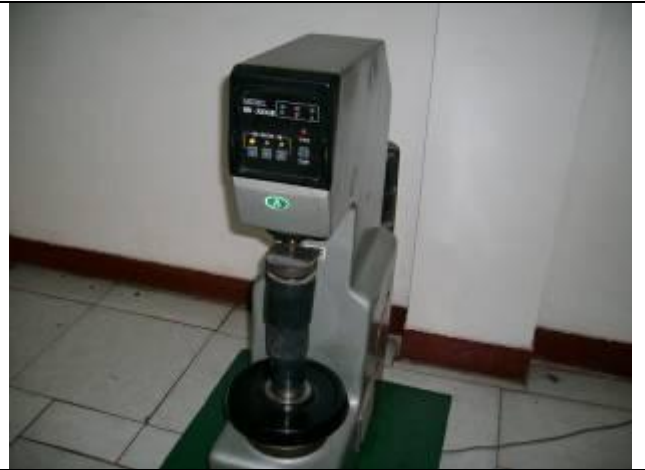
Mechanical properties testing

Result: Passed.
