Inspection Order No. : IN-TJ-5301-12116-01
BOSS No: 1126376
Page No. : 1 of 8
Date of issue: Aug 19 2012

INSPECTION REPORT
 (non-negotiable)

- Description and Quantity of Commodity: Ductile pipe DN500
- Name & Address Of Buyer: L*****
- Name & Address Of Seller: SHANXI SOLID INDUSTRIAL CO.,LTD
- Inspection Date & Place: Aug 16~18 2012 Shanxi province, China.
- L/C No.:
- P/I No.: SFC-1205A
- Nature Of Inspection:

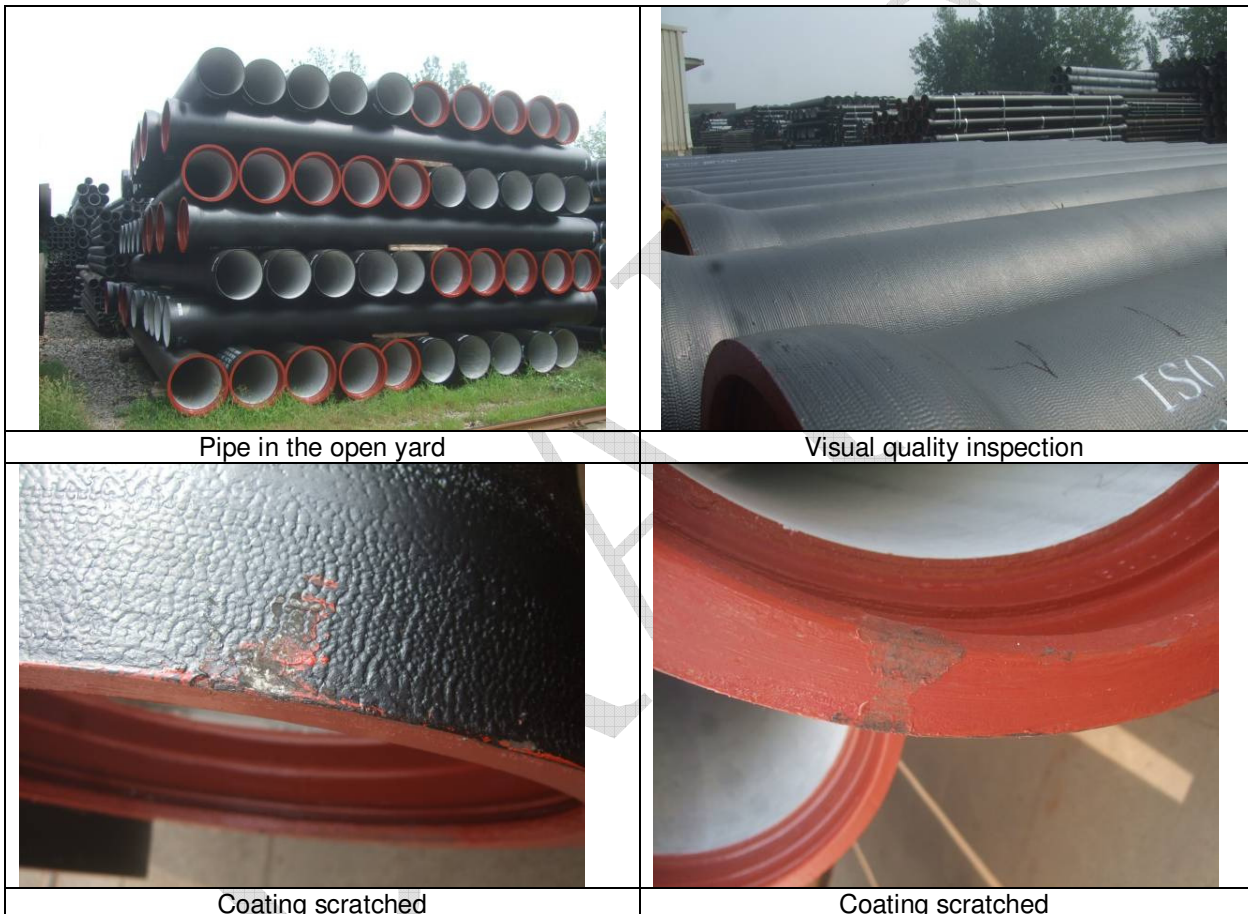
During inspection, the pipes were selected randomly for visual quality inspection. The pipes were found painted with black paint on external surface and lined with gray lining in internal surface, the socket of the pipe was found painted with red paint on internal surface. Except the 4pcs pipe coating scratched, no obvious defect on the visual quality of the pipes was found on site.

<p>Visual quality inspection</p>	<p>Visual quality inspection</p>

<p>Marking inspection</p>	<p>Marking inspection</p>

- The manufacturer declares that they will re-coat scratch area.

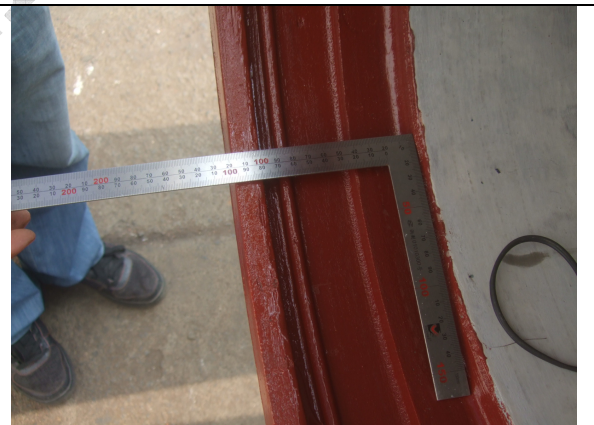
Socket depth

Remark: Except the no tolerance for T1, other dimension was in according with required value.
