Inspection Order No. : IN-TJ-5602-15198Upd.02
BOSS No. : 1331823
Page No. : 1 of 8
Date of issue: Sep.22, 2015

INSPECTION REPORT

- **Description and Quantity of Commodity (As per PI declared):** Steel pipe seamless DN600 e=8mm ASTM A53 GR-B ,internal and external epoxy coating L=12m
48 pcs

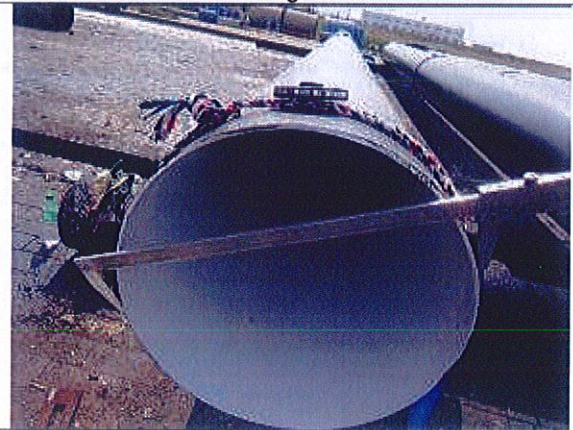
Dimension check

In order to traceability of inspection, SGS inspector made mark and signed on pipe surface, details as attached pictures. Wall thickness was measured randomly at 4 points by micrometer on circumference direction of each pipe's both ends, and measured randomly at 4 points by thickness gauge on each pipe's body. Outside diameter at ends was measured by caliper at 2 points cross direction at two side pipe ends. Circumference was firstly measured by tape in 2 positions on the body, and outside diameter on body was calculated from circumference divided by 3.14. Details were as following.

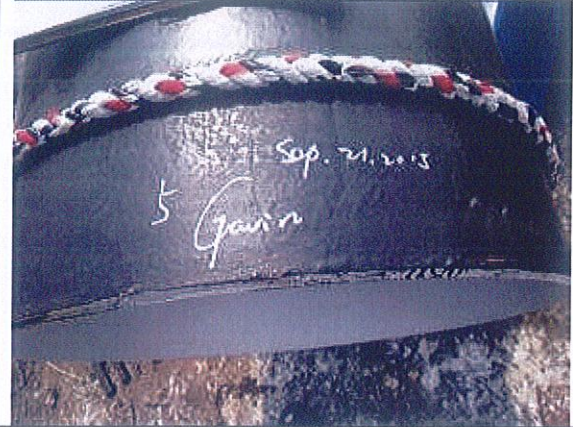
<p>N/A</p>
<p>SGS marking on pipe</p>	<p>N/A</p>
